ARBORIST REPORT

**PROPOSED MIXED-USE DEVELOPMENT
HERON'S HILL WAY & SHEPPART AVE. EAST
CITY OF TORONTO**

**ISA CERTIFIED ARBORIST
MATTHEW GEHRES ON-1114A
OUR PROJECT NO:
19-5411**

April 2020

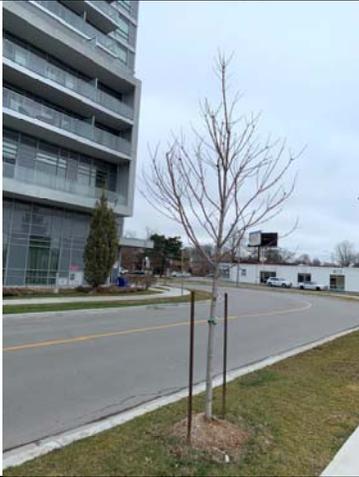
Tree# 1

| EXISTING TREE INVENTORY | | | | | | | | | |
|---|---|---|---|---|---|---|---|---|---|
| 1 | FREEMAN MAPLE | 6.0 | 2.5 | GOOD | RECENTLY PLANTED STREET TREE. | REMOVE | 1.2 | 5 | 1 |

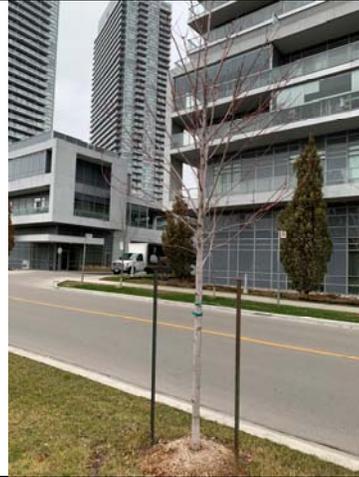
Tree# 2

| EXISTING TREE INVENTORY | | | | | | | | | |
|---|---|---|---|---|---|---|---|---|---|
| 2 | FREEMAN MAPLE | 6.0 | 2.5 | GOOD | RECENTLY PLANTED STREET TREE. | PRESERVE | 1.2 | 5 | 2 |

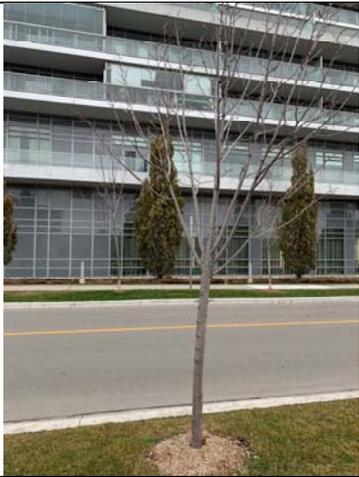
Tree# 3

| EXISTING TREE INVENTORY | | | | | | | | | |
|---|---|---|---|---|---|---|---|---|---|
| 3 | LINDEN | 8.0 | 2.5 | GOOD | RECENTLY PLANTED STREET TREE. | PRESERVE | 1.2 | 5 | 3 |

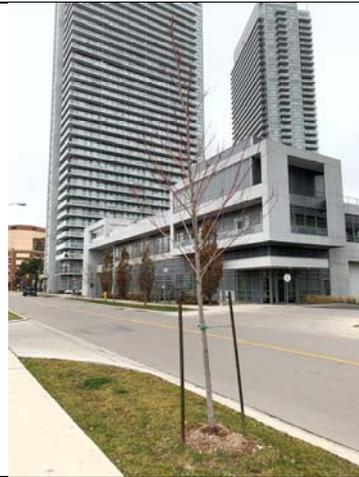
Tree# 4

| EXISTING TREE INVENTORY | | | | | | | | | |
|---|---|---|---|---|---|---|---|---|---|
| 4 | FREEMAN MAPLE | 6.0 | 2.5 | GOOD | RECENTLY PLANTED STREET TREE. | PRESERVE | 1.2 | 5 | 4 |

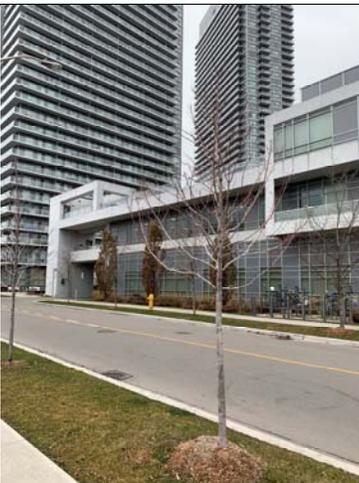
Tree# 5

| EXISTING TREE INVENTORY | | | | | | | | | |
|---|---|---|---|---|---|---|---|---|---|
| 5 | FREEMAN MAPLE | 7.0 | 2.5 | GOOD | RECENTLY PLANTED STREET TREE. | PRESERVE | 1.2 | 5 | 5 |

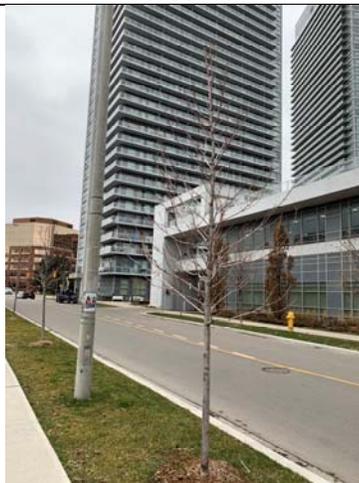
Tree# 6

| EXISTING TREE INVENTORY | | | | | | | | | |
|---|---|---|---|---|---|---|---|---|---|
| 6 | FREEMAN MAPLE | 7.0 | 2.5 | GOOD | RECENTLY PLANTED STREET TREE. | PRESERVE | 1.2 | 5 | 6 |

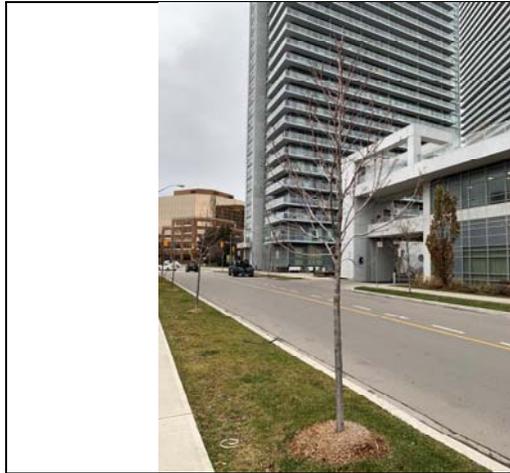
Tree# 7

| EXISTING TREE INVENTORY | | | | | | | | | |
|---|---|---|---|---|---|---|---|---|---|
| 7 | FREEMAN MAPLE | 6.0 | 2.5 | GOOD | RECENTLY PLANTED STREET TREE. | REMOVE | 1.2 | 5 | 7 |

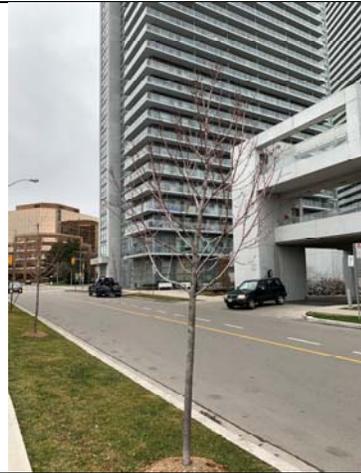
Tree# 8

| EXISTING TREE INVENTORY | | | | | | | | | |
|---|---|---|---|---|---|---|---|---|---|
| 8 | FREEMAN MAPLE | 6.0 | 2.5 | GOOD | RECENTLY PLANTED STREET TREE. | REMOVE | 1.2 | 5 | 8 |

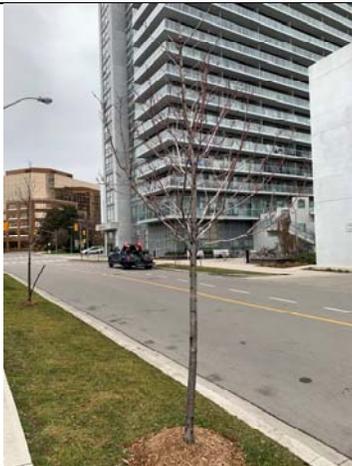
Tree# 9

| EXISTING TREE INVENTORY | | | | | | | | | |
|---|---|---|---|---|---|---|---|---|---|
| 9 | FREEMAN MAPLE | 7.0 | 2.5 | GOOD | RECENTLY PLANTED STREET TREE. | PRESERVE | 1.2 | 5 | 9 |

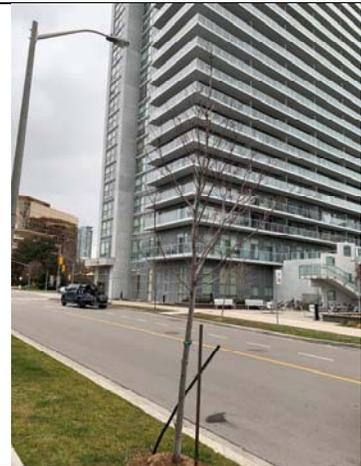
Tree# 10

| EXISTING TREE INVENTORY | | | | | | | | | |
|---|---|---|---|---|---|---|---|---|---|
| 10 | FREEMAN MAPLE | 6.0 | 2.5 | GOOD | RECENTLY PLANTED STREET TREE. | PRESERVE | 1.2 | 5 | 10 |

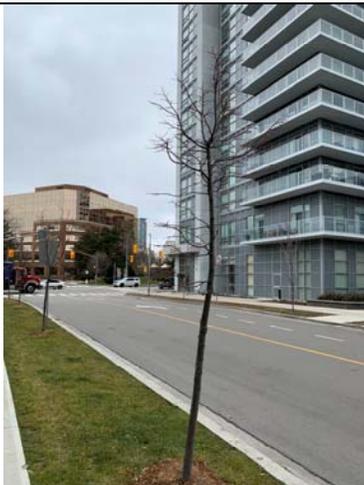
Tree# 11

| EXISTING TREE INVENTORY | | | | | | | | | |
|---|---|---|---|---|---|---|---|---|---|
| 11 | LINDEN | 7.0 | 2.5 | FAIR | RECENTLY PLANTED STREET TREE, NARROW FORM | PRESERVE | 1.2 | 5 | 11 |

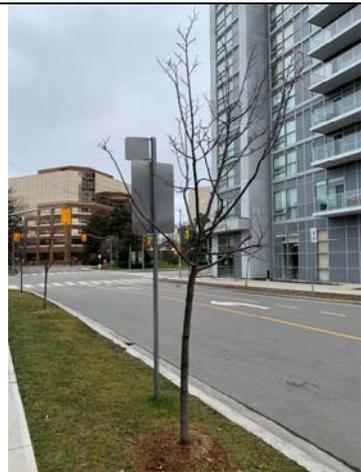
Tree# 12

| EXISTING TREE INVENTORY | | | | | | | | | |
|---|---|---|---|---|---|---|---|---|---|
| 12 | FREEMAN MAPLE | 7.0 | 2.5 | FAIR | RECENTLY PLANTED STREET TREE. | PRESERVE | 1.2 | 5 | 12 |

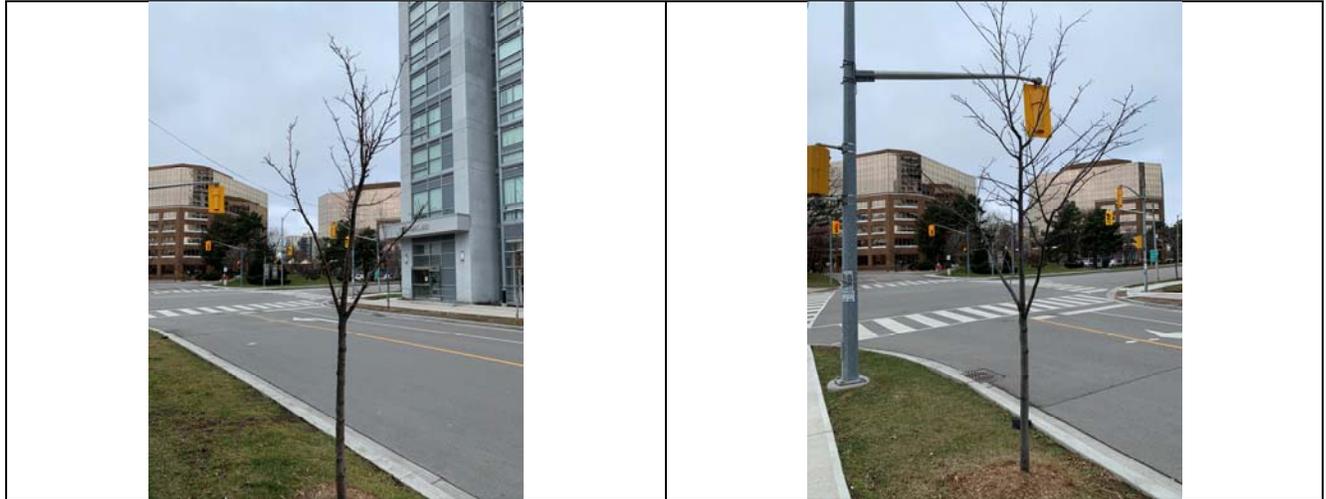
Tree# 13

| EXISTING TREE INVENTORY | | | | | | | | | |
|---|---|---|---|---|---|---|---|---|---|
| 13 | FREEMAN MAPLE | 6.0 | 2.0 | FAIR | RECENTLY PLANTED STREET TREE, SPARSE. | PRESERVE | 1.2 | 5 | 13 |
| 14 | FREEMAN MAPLE | 7.0 | 3.0 | GOOD | RECENTLY PLANTED STREET TREE. | PRESERVE | 1.2 | 5 | 14 |

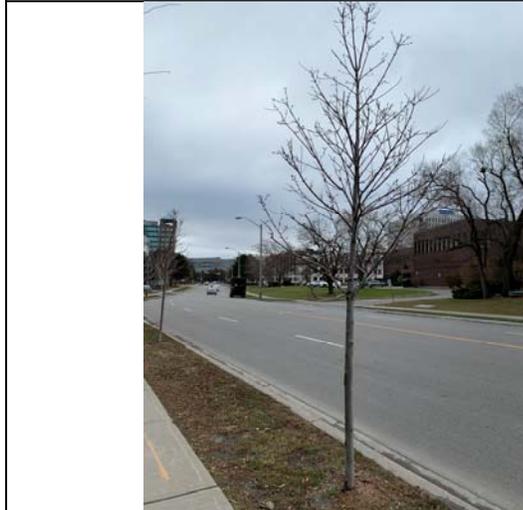
Tree# 15

| EXISTING TREE INVENTORY | | | | | | | | | |
|---|---|---|---|---|---|---|---|---|---|
| 15 | FREEMAN MAPLE | 7.0 | 3.0 | GOOD | RECENTLY PLANTED STREET TREE. | PRESERVE | 1.2 | 5 | 15 |

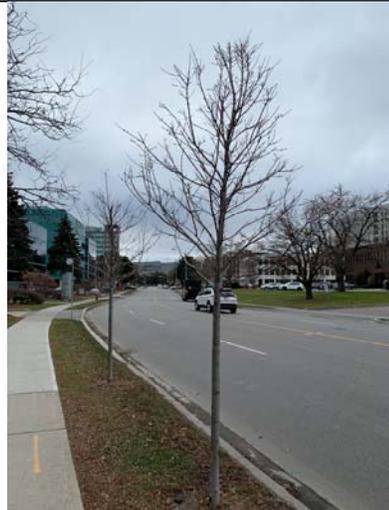
Tree# 16

| EXISTING TREE INVENTORY | | | | | | | | | |
|---|---|---|---|---|---|---|---|---|---|
| 16 | FREEMAN MAPLE | 7.0 | 3.0 | GOOD | RECENTLY PLANTED STREET TREE. | PRESERVE | 1.2 | 5 | 16 |

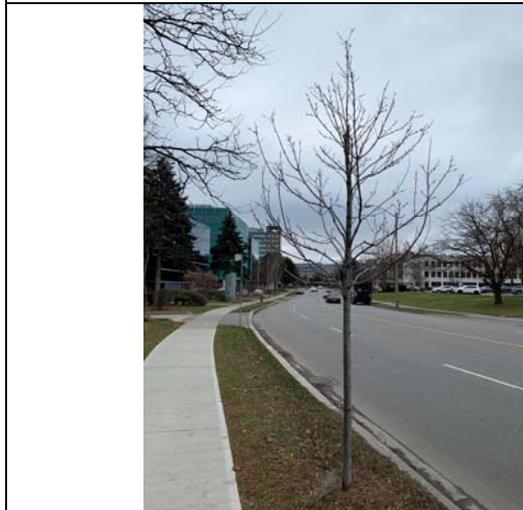
Tree# 17

| EXISTING TREE INVENTORY | | | | | | | | | |
|---|---|---|---|---|---|---|---|---|---|
| 17 | FREEMAN MAPLE | 6.0 | 3.0 | GOOD | RECENTLY PLANTED STREET TREE. | PRESERVE | 1.2 | 5 | 17 |

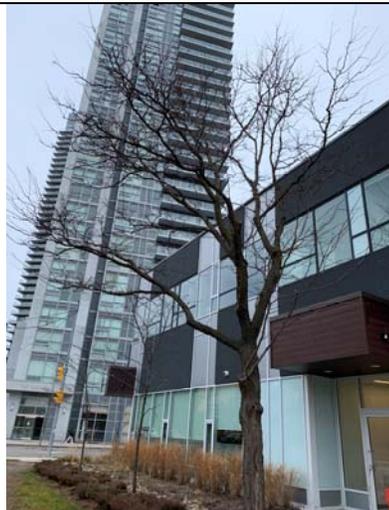
Tree# 18

| EXISTING TREE INVENTORY | | | | | | | | | |
|---|---|---|---|---|---|---|---|---|---|
| 18 | HONEY LOCUST | 32.0 | 8.0 | FAIR | MAJOY HEALED SPLIT IN TRUNK | PRESERVE | 2.4 | 5 | 18 |

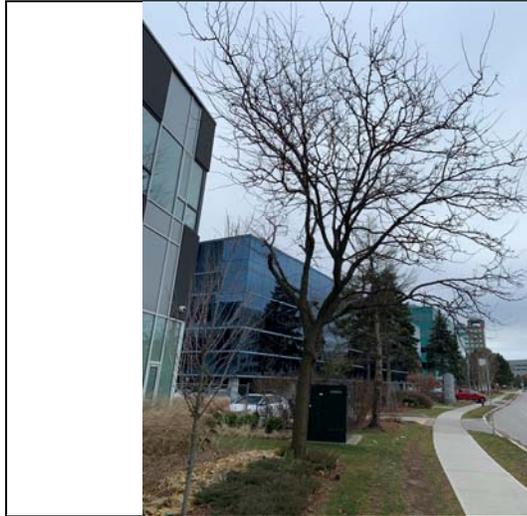
Tree# 19

| EXISTING TREE INVENTORY | | | | | | | | | |
|---|---|---|---|---|---|---|---|---|---|
| 19 | HONEY LOCUST | 32.0 | 10.0 | GOOD | GOOD FORM | PRESERVE | 2.4 | 5 | 19 |

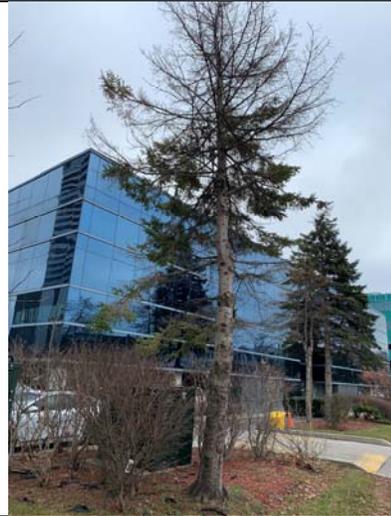
Tree# 20

| EXISTING TREE INVENTORY | | | | | | | | | |
|---|---|---|---|---|---|---|---|---|---|
| 20 | WHITE SPRUCE | 33.0 | 5.0 | POOR | VERY SPARSE, DECLINING, LEADER DEAD. | PRESERVE | 2.4 | 5 | 20 |

Generally, with the exception of the White Spruce in front of the adjacent property to the south, all trees inventoried are currently in fair to good overall health and condition.

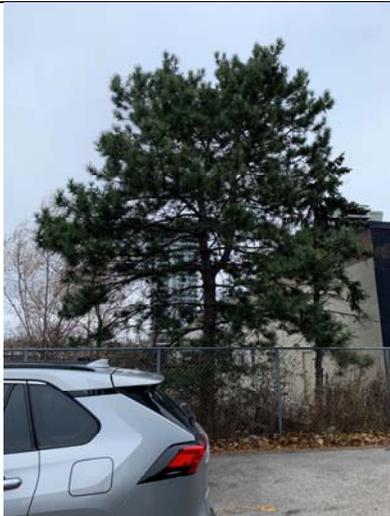
Tree# 21

| EXISTING TREE INVENTORY | | | | | | | | | |
|---|---|---|---|---|---|---|---|---|---|
| 21 | AUSTRIAN PINE | 41.0 | 7.5 | GOOD | FULL FORM, CODOMINANT LEADERS. | PRESERVE | 3 | 2 | 21 |

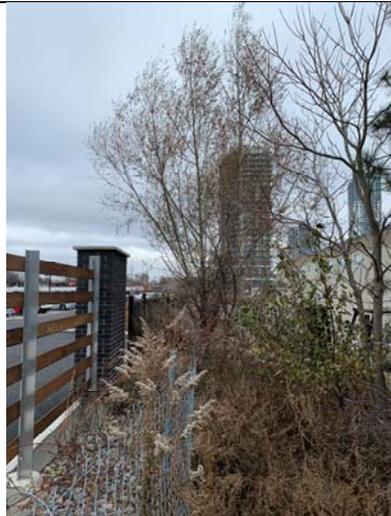
Tree# 22

| EXISTING TREE INVENTORY | | | | | | | | | |
|---|---|---|---|---|---|---|---|---|---|
| 22 | WILLOW | 20.0 | 5.0 | GOOD | CLUMP, LOW BRANCHING. | PRESERVE | 1.8 | EXEMPT | 22 |
